McWAIN POND WATERSHED SURVEY

**Lakes Environmental Association
McWain Pond Association
Maine Department of Environmental Protection**

March 2007

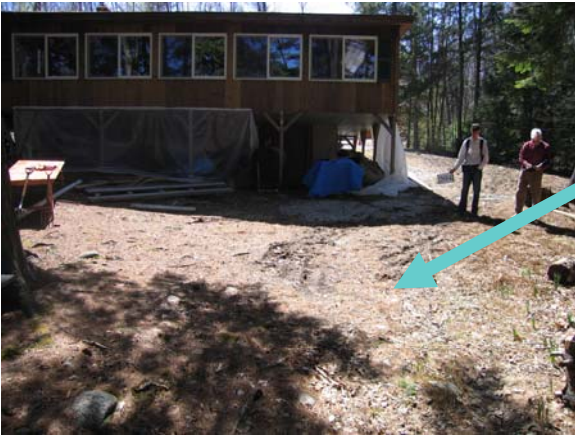
Problems:

- No erosion control at construction site
- Bare soil with potential erosion to the pond

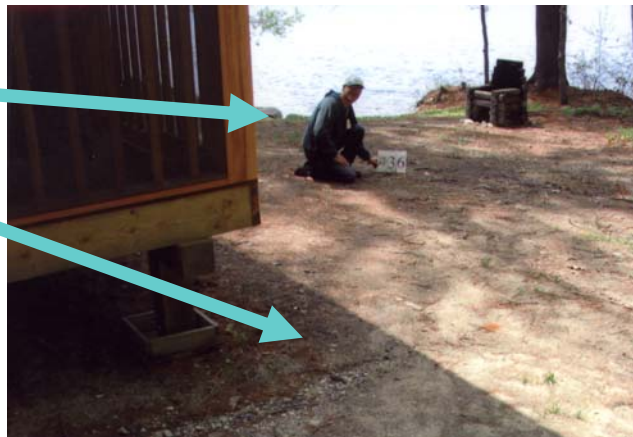
- Lack of buffer along shoreline
- Bare soil with direct flow to pond
- Roof runoff causes erosion

Solutions:

- Establish buffer along shoreline
- Seed and mulch bare areas
- Install dripline trench to catch roof runoff

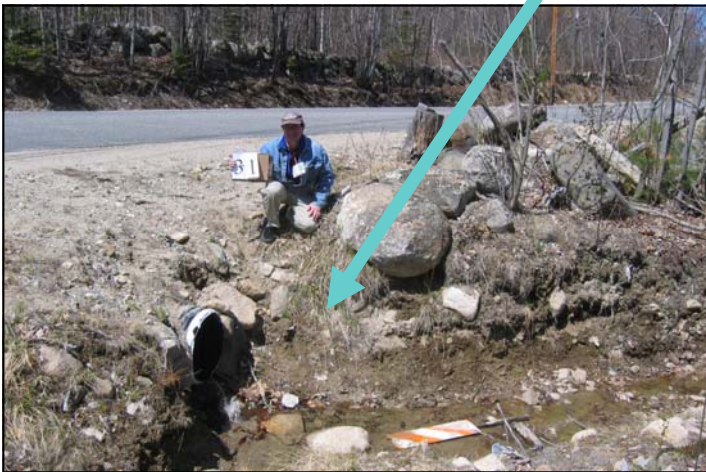
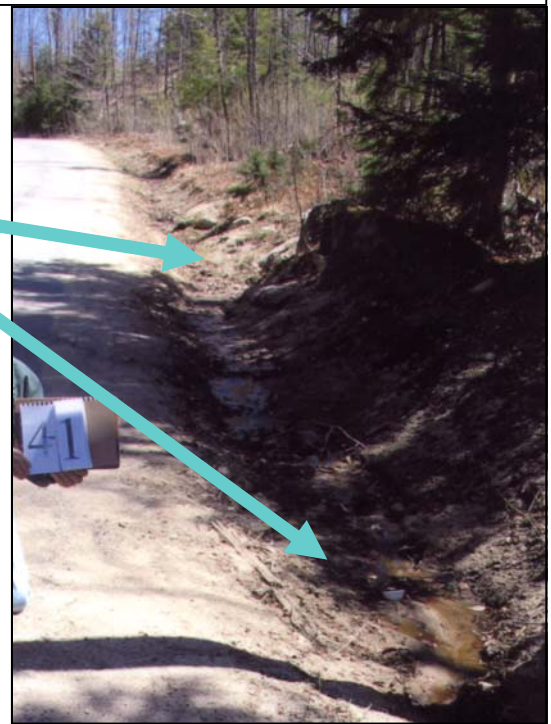
Problems:

- Winter sand runs off shoulder
- Bare soil on ditch backslope
- Ditch poorly shaped
- Direct flow of sediment to stream
- Runoff from shoulder and unstable culvert outlet

Solutions:

- Install plunge pool to catch winter sand and eroding soil before it enters stream
- Reshape ditch
- Vegetate bare backslope
- Install rock or plant grass to stabilize ditch
- Armor culvert outlet
- Lengthen culvert to allow gentler slope for shoulder and plant grass or shrubs on bare soil

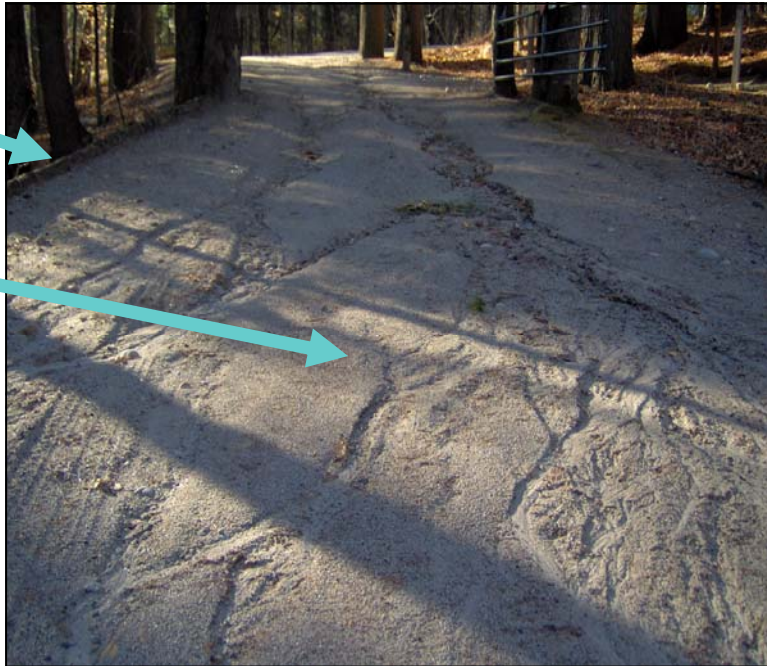
- Berm keeps water on driveway where it can erode surface
- Poor shaping causes water to concentrate which forms ruts
- Direct flow of sediment to tributary

Solutions:

- Add new surface material
- Reshape driveway so water moves quickly from the surface
- Install diverters such as waterbars, open-top culverts or rubber razors to move water off driveway
- Remove berm

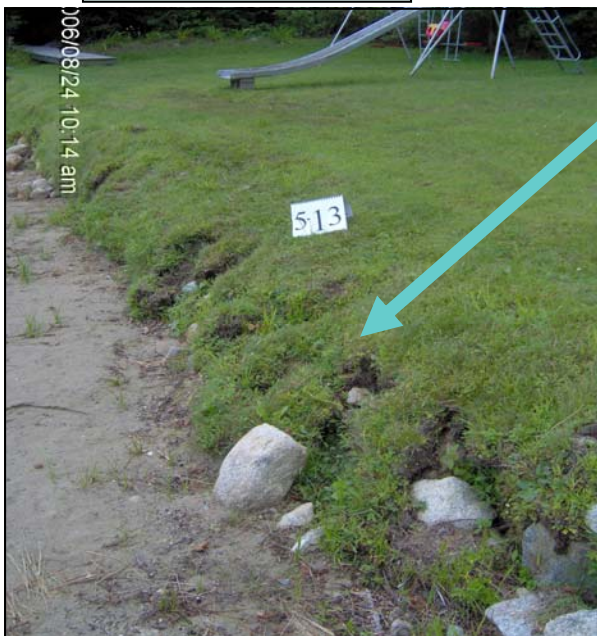
Beach

Problems:

- Collapsing shoreline
- Lack of vegetation

- Plant buffer above collapsing rock wall to stabilize shoreline

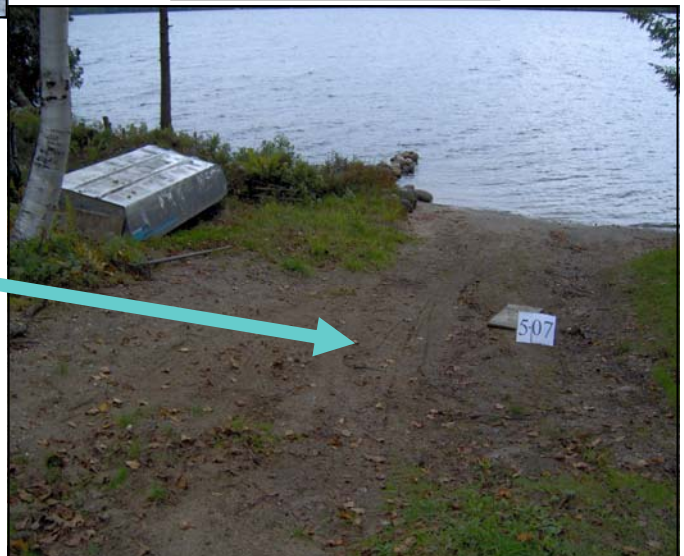
Boat Access

Problems:

- Direct flow of sediment to pond
- Lack of vegetation
- Slight surface erosion

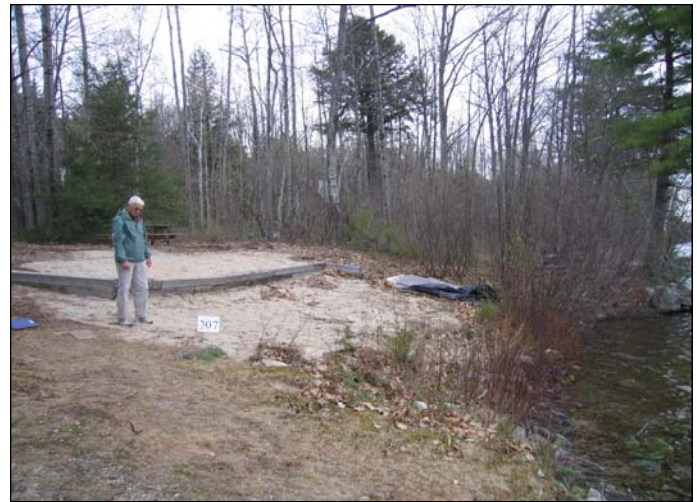
The beaches have sandy areas for children, picnic tables, boat racks, grass and moss. It has been a challenge to keep sand from washing into the pond. The watershed survey found both beaches present “medium” erosion impacts to McWain Pond. In the past, sand was added to replace eroded material. McWain Shores residents recognize this practice is no longer allowed by state law and has, perhaps, contributed to the degradation of the pond.

McWain Shores South Beach in May 2006.

The untreated wooden retaining wall will be repaired and raised slightly to hold sand back better. The retaining wall will be reinforced with a layer of fabric and rock (fitted to minimize exposed jagged edges). Work will begin in Spring 2007.

In addition, the shore buffer, currently subject to erosion during spring melt and torrential rains, will be widened by adding a band of low bush blueberry and eastern sand cherry. Both species are native, hardy, attractive and relatively unobtrusive. Mulch will be added to stabilize the plantings. The area of bare soil adjacent to the shore will be minimized. All these measures should significantly reduce sand movement from the upper sandy area to the pond.
