McWAIN POND WATERSHED SURVEY

**Lakes Environmental Association
McWain Pond Association
Maine Department of Environmental Protection**

March 2007

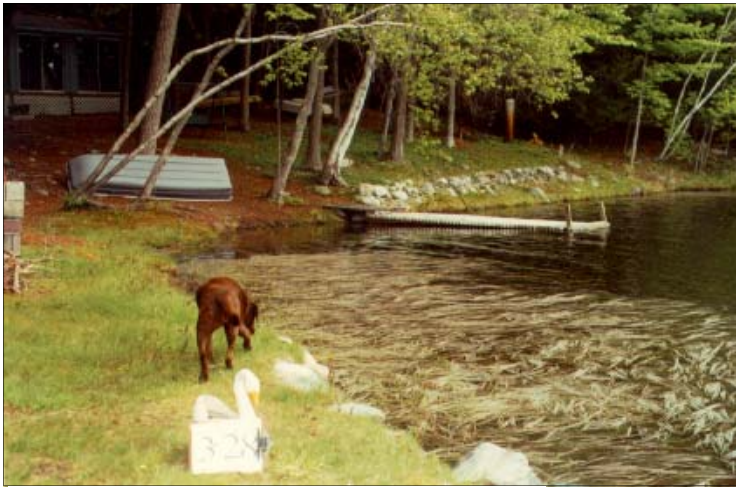
Numerous lakeshore properties were observed to have little or no **vegetated buffer** at the water's edge. It is important to note that buffers of shrubs and trees do a much more effective job than bare ground or grass at keeping **NPS** pollution from entering lakes. Deep shrub and tree roots also help hold the shoreline.

Buffers can be installed inexpensively. You can either stop mowing, stop raking to the water's edge and let plants grow up naturally (as in the picture on the right). Or you can plant the area with native trees and shrubs.

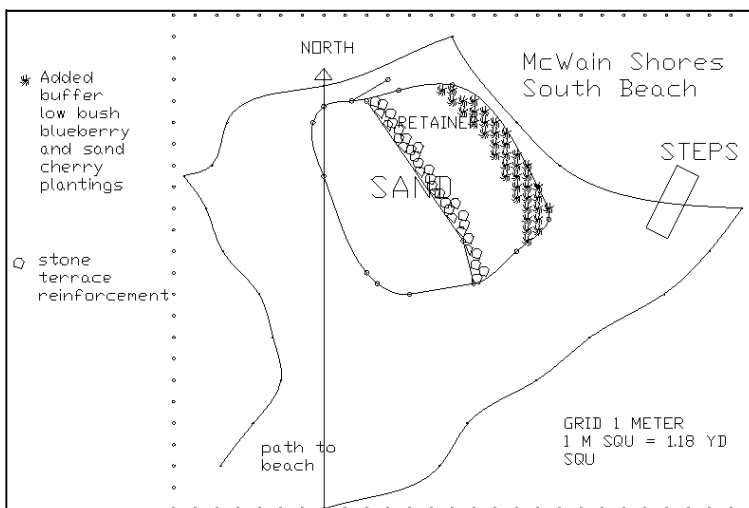
The beaches have sandy areas for children, picnic tables, boat racks, grass and moss. It has been a challenge to keep sand from washing into the pond. The watershed survey found both beaches present “medium” erosion impacts to McWain Pond. In the past, sand was added to replace eroded material. McWain Shores residents recognize this practice is no longer allowed by state law and has, perhaps, contributed to the degradation of the pond.

The untreated wooden retaining wall will be repaired and raised slightly to hold sand back better. The retaining wall will be reinforced with a layer of fabric and rock (fitted to minimize exposed jagged edges). Work will begin in Spring 2007.

In addition, the shore buffer, currently subject to erosion during spring melt and torrential rains, will be widened by adding a band of low bush blueberry and eastern sand cherry. Both species are native, hardy, attractive and relatively unobtrusive. Mulch will be added to stabilize the plantings. The area of bare soil adjacent to the shore will be minimized. All these measures should significantly reduce sand movement from the upper sandy area to the pond.
